NBSIR 80-2122

Development of Guide Specifications for the 1980 Exterior Restoration of the White House

October 1980

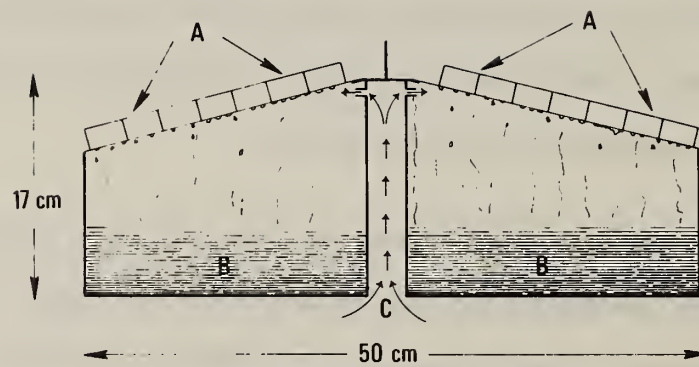
FIGURE 1. WATER CONDENSATION APPARATUS

The test specimens, coated on five sides, were mounted over the bath at an angle of 45° with the uncoated side facing away from the water bath. Specimens were examined periodically during testing for signs of degradation. After 500 cycles (1000 hours), specimens were removed from the bath, visually inspected, and equilibrated at constant humidity/temperature before determining color difference.

- A -- TEST SPECIMENS.
B -- WATER BATH.
C -- DUCT FOR FORCED-AIR DRYING.

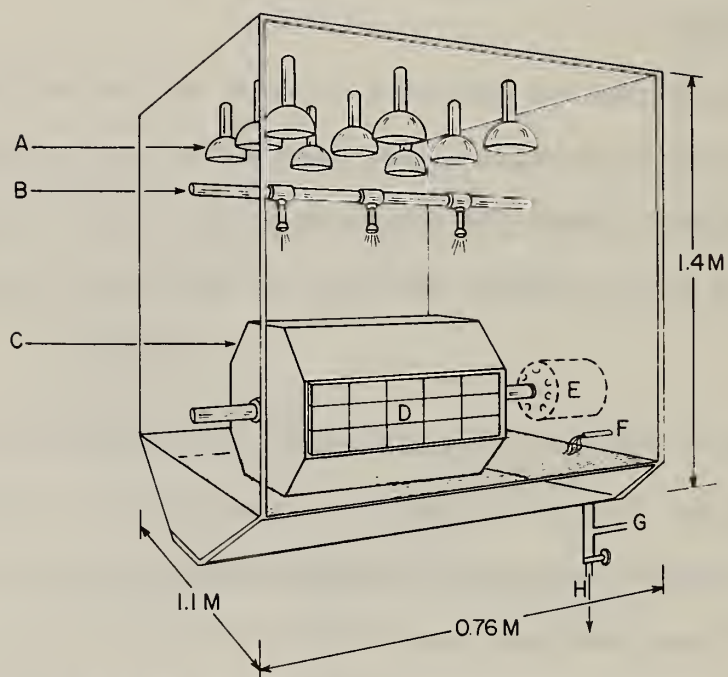
FIGURE 2. CHAMBER FOR ACCELERATED DECAY (CAD)

The CAD, which is built of stainless steel, is illustrated in figure 2. Its features include: A) three infrared and six ultraviolet (UV) lamps; B) a water spray; C) a revolving eight-sided specimen drum; D) each face of the drum can hold up to 15 test specimens [each 4 x 4 x 1 in (10 x 10 x 2.5 cm)] on removable plates; E) a motor and reduction gearbox for rotation of the specimen drum; F) an inlet for corrosive test solutions; G) an outlet through which the corrosive test solution can be pumped back to storage for reuse; and H) a drain that can be completely closed by a valve when the corrosive test solution is being used, or only partially closed by a stand pipe during water-soaking of the specimens.

- A - HEAT & ULTRAVIOLET LAMPS
- B - WATER SPRAY
- C - ROTATING SPECIMEN DRUM
- D - FIFTEEN STONE SPECIMENS MOUNTED ON ONE FACE OF SPECIMEN DRUM
- E - MOTOR & GEAR TO ROTATE SPECIMEN DRUM AT 1 RPM
- F - INLET FOR CORROSIVE TEST SOLUTIONS
- G - OUTLET FOR STORAGE OF CORROSIVE TEST SOLUTIONS
- H - OUTLET TO DRAIN

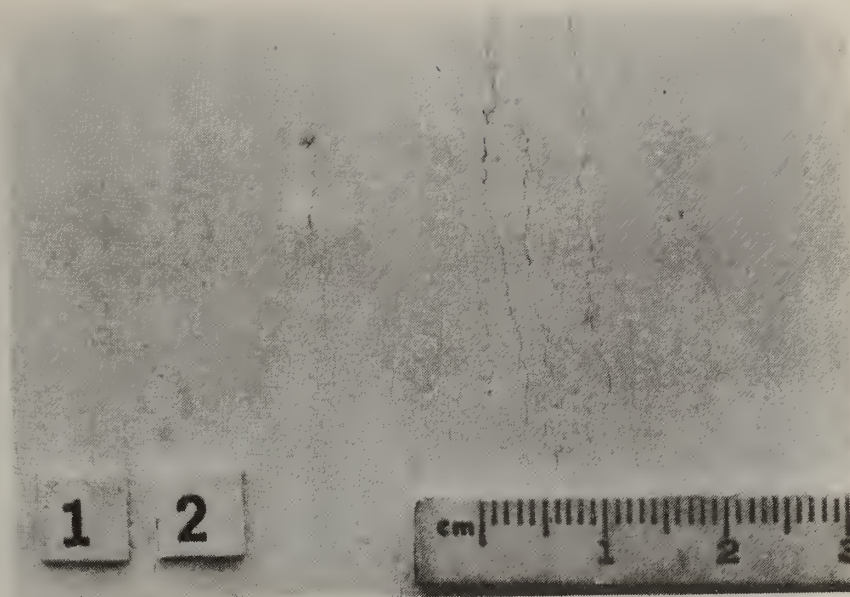
FIGURE 3. COATING 1 AFTER CAD EXPOSURE (20 CYCLES)

After 10 test cycles, cracks were observed in the specimens of coatings 1 and 2. After 20 cycles, cracks were observed in specimens of coatings 1, 2 and 3; only coating 4 specimens had no cracks in the coated surface. Photographs of specimens of coatings 1, 2, 3 and 4 are shown in figures 3, 4, 5, and 6, respectively.

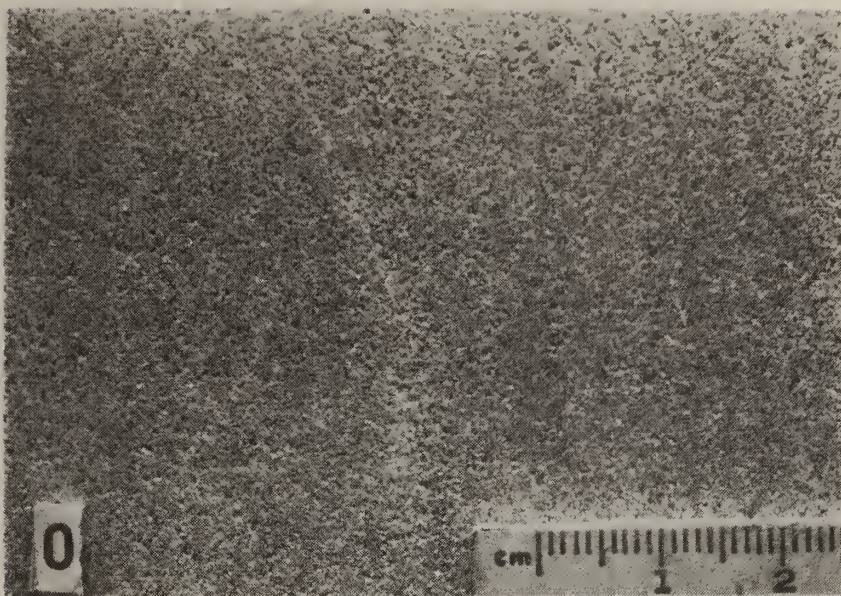
FIGURE 7. UNEXPOSED SANDSTONE

The specimens of the uncoated sandstone showed a loosening of the surface granules after 20 cycles. This difference between the unexposed sandstone and the exposed sandstone may be noted in figures 7 and 8.

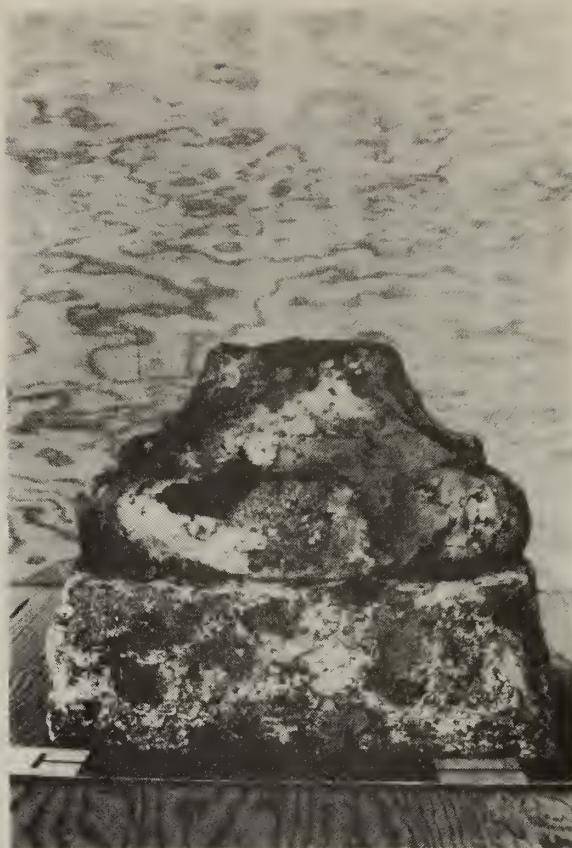
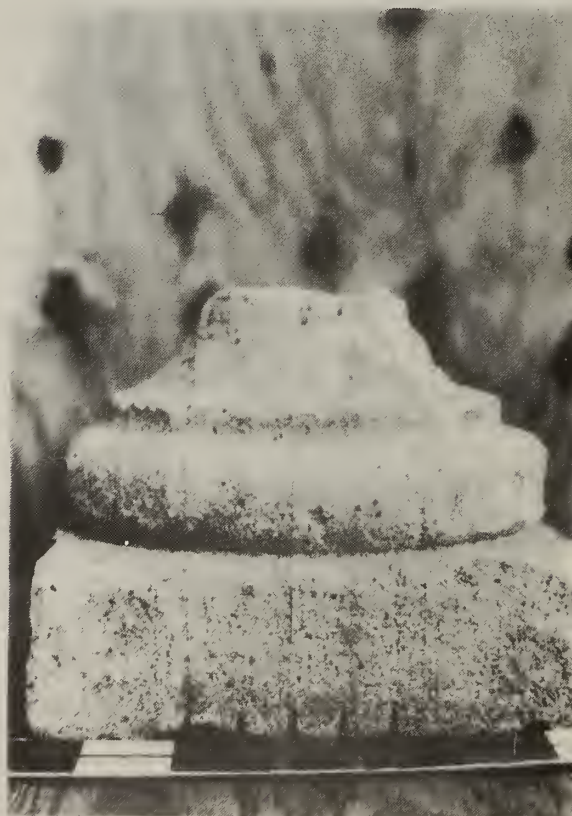
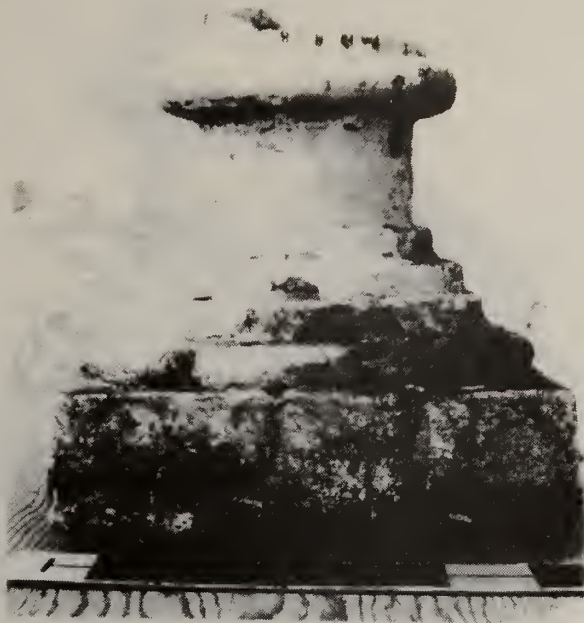
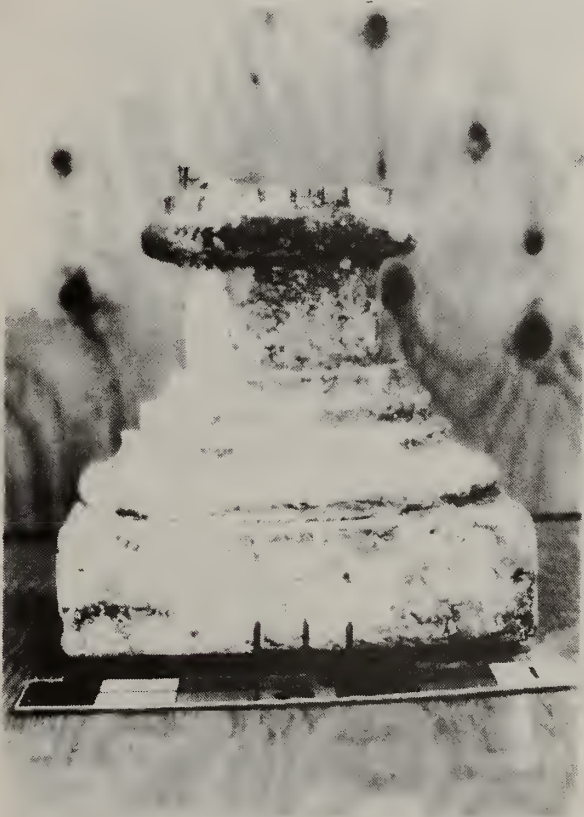
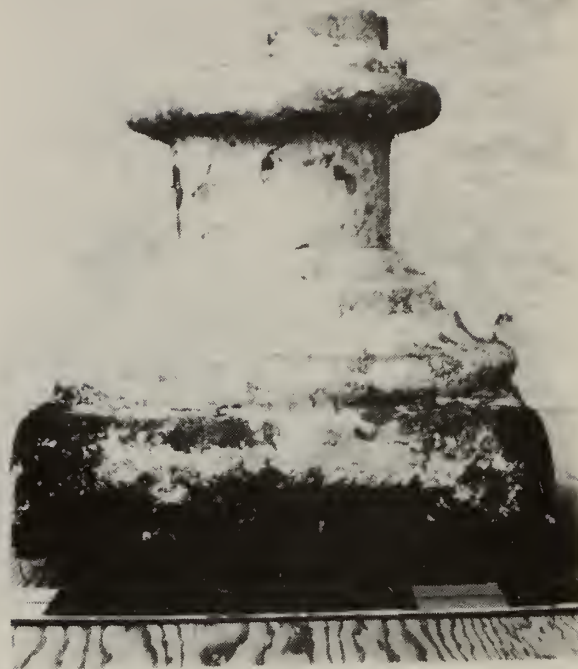
Figures 10-17 illustrate that all four paint removal methods evaluated in the preliminary tests were effective in removing paint from the balustrades of the Capitol, although the commercial firms did not all attempt to remove all of the paint. Since the balustrades had been stored in the open in Rock Creek Park since the expansion of the east front of the Capitol, part

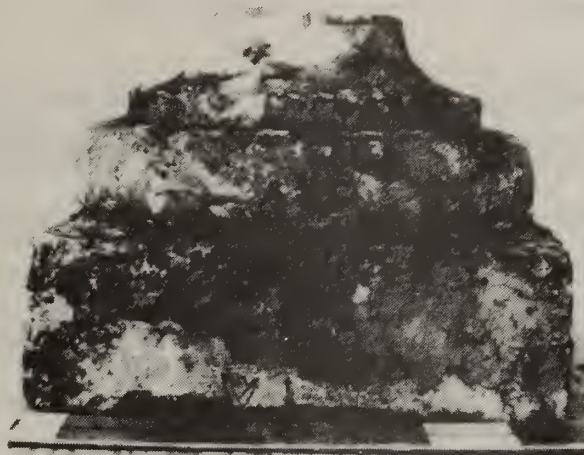
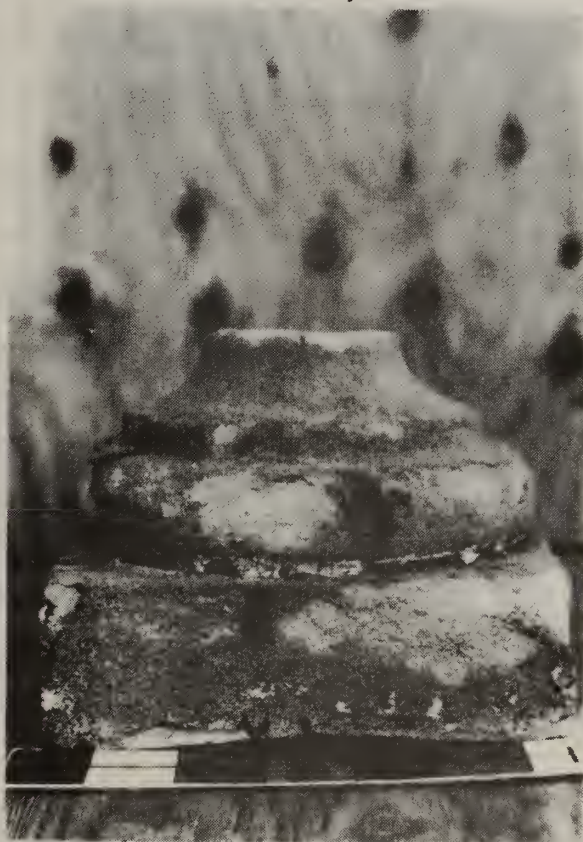
The fourth method evaluated (Method 4) was a prototype system using a special pressure-adjustable nozzle to project a mixture of water, sand, and air. Figures 16 and 17 illustrate the balustrade before and after paint removal by Method 4.

FIGURE 16. STONE SPECIMEN 6, BEFORE PAINT REMOVAL

FIGURE 17. STONE SPECIMEN 6, AFTER PAINT REMOVAL BY METHOD 4

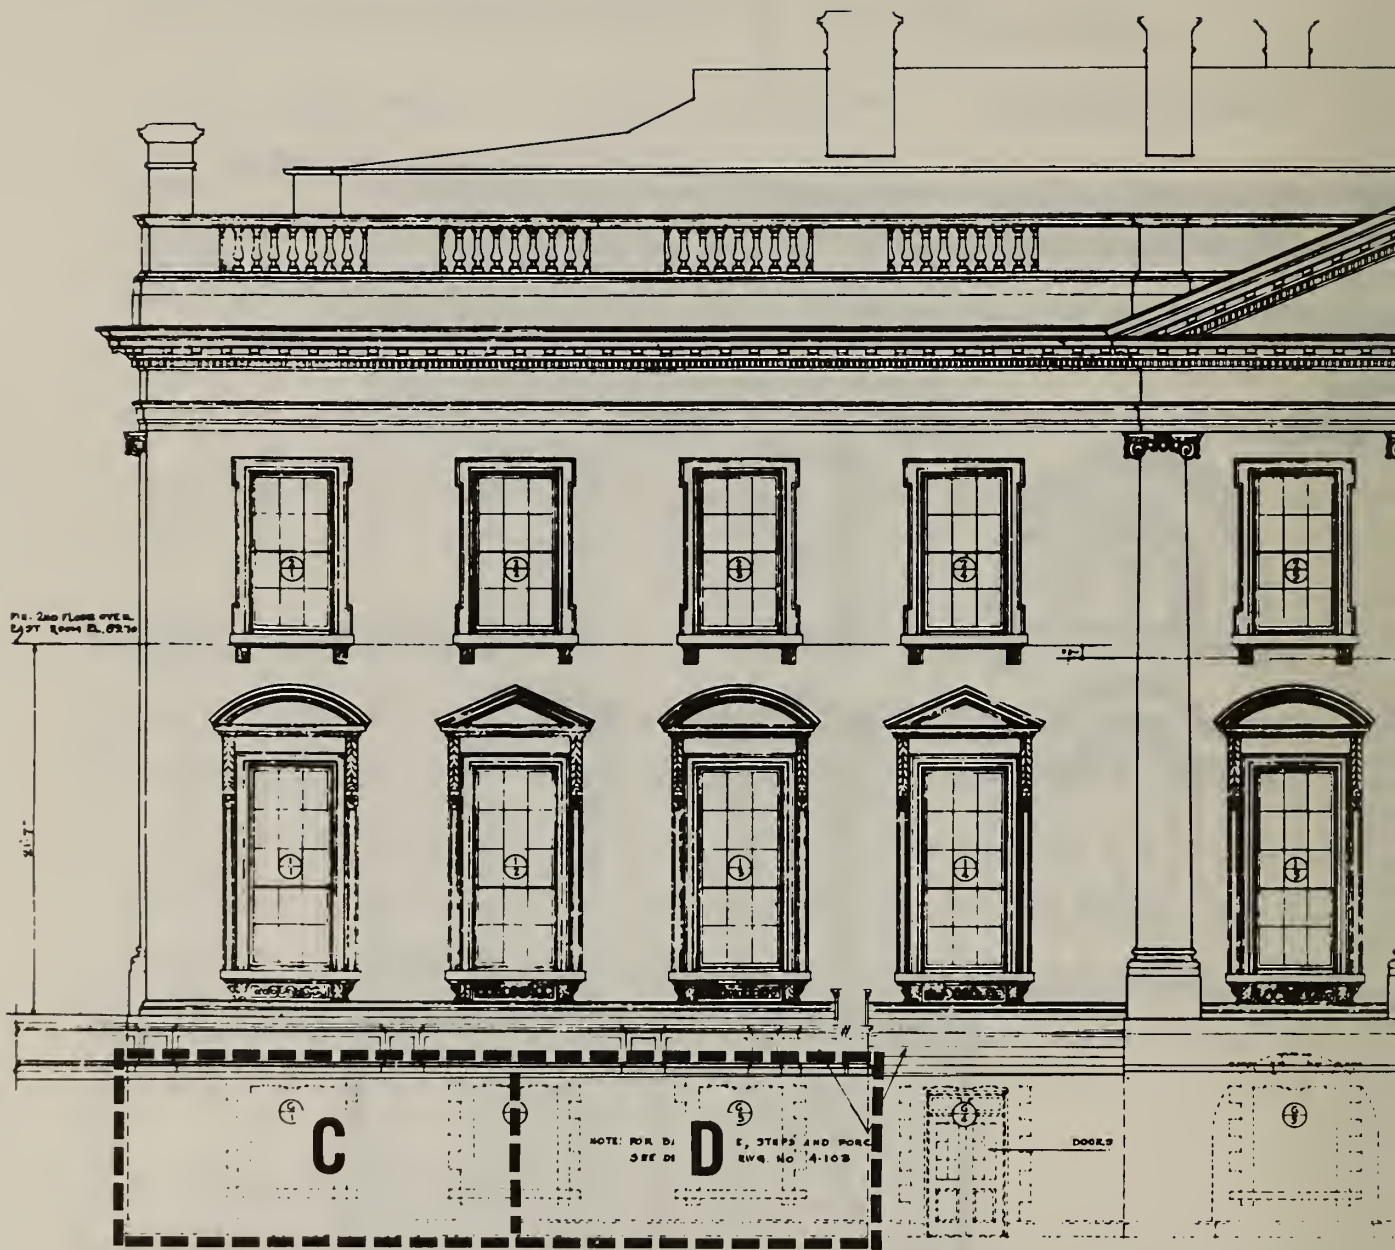
FIGURE 19. WHITE HOUSE - NORTH ELEVATION TEST AREA

<u>Area</u>	<u>Paint Removal Technique</u>
A	Combination hand cleaning, chemical treatment, water spray (Method 2)
B	Chemical treatment/high pressure water spray (Method 1)
C	Abrasive blasting with aluminum beads (Method 3)
D	Hand scraping and chipping

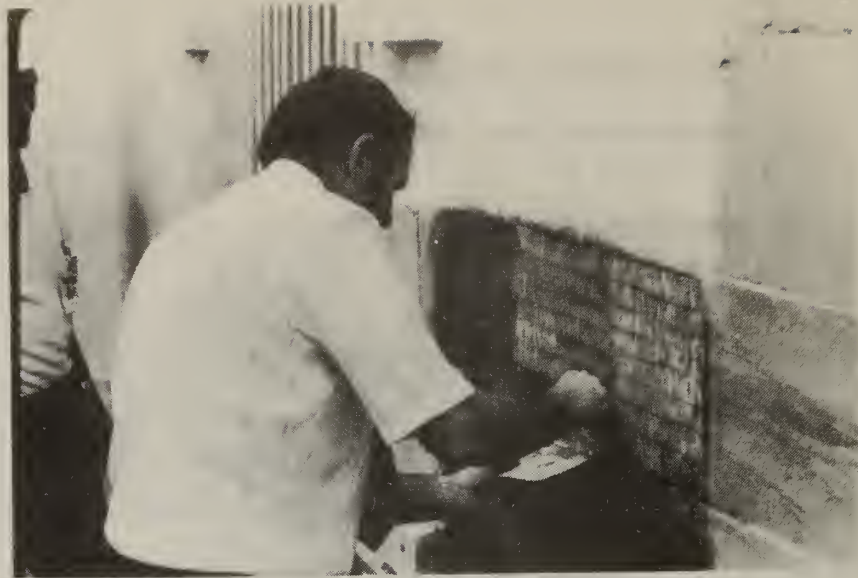
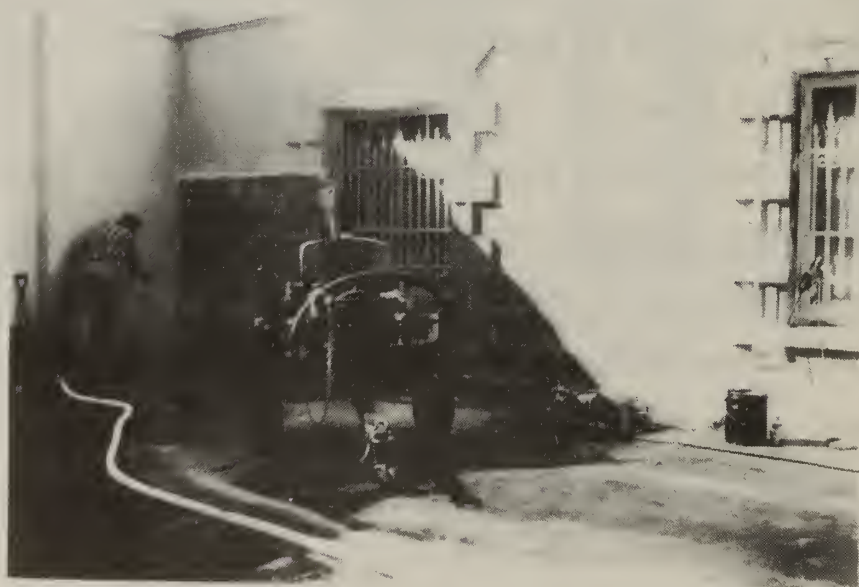
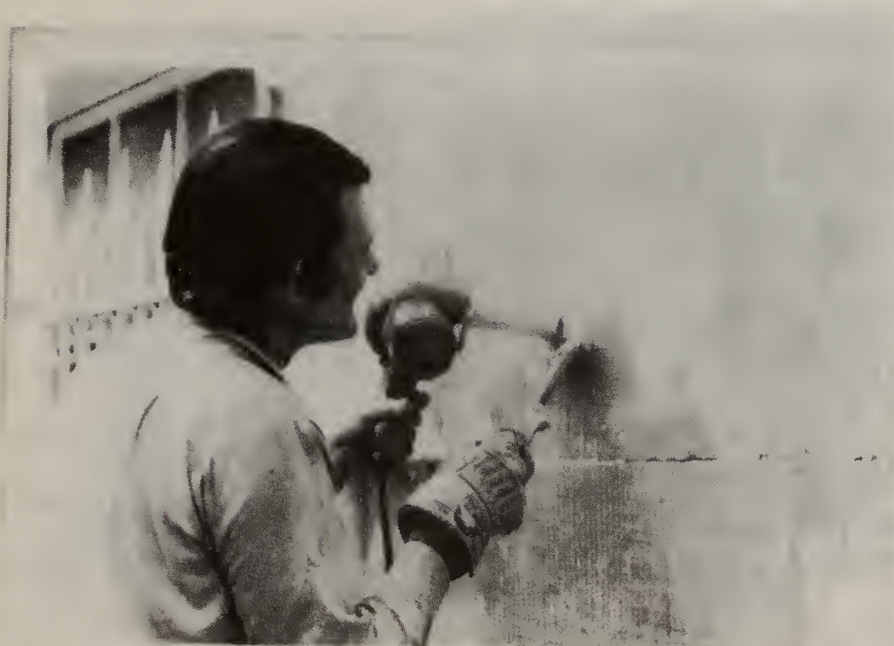
Test Area A was cleaned on August 30-31 and October 10-11, 1978 by Company 2, using a combination of cleaning techniques. The procedure consisted of 1) scraping the old paint by hand, taking care to avoid damaging the fluting on the stone, (see figure 20), 2) applying an alkaline paint remover, 3) scouring the paint with a wire brush, and 4) rinsing the surface with high-pressure water spray (see figures 21 and 22). In addition, a heat gun was used in a small area to soften the paint, which was then scraped off. This process is shown in figure 23. The equipment used in the operation included hand tools, air compressor and spray apparatus and required 110V electrical and water services. A temporary asphalt-plastic filler dam was constructed to contain water run off (see figure 21). Figure 24 shows test Areas A and B prior to paint removal. Approximately 3/4 of the paint on Area A was removed by the cleaning process.

FIGURE 20. PAINT REMOVAL IN AREA A, SCRAPING OFF PAINT
AFTER SOFTENING WITH PAINT REMOVER

FIGURE 21. PAINT REMOVAL IN AREA A, USING HIGH PRESSURE
WATER SPRAY

FIGURE 22. PAINT REMOVAL IN AREA A, USING HIGH PRESSURE WATER SPRAY

FIGURE 23. PAINT REMOVAL IN AREA A, USING HEAT GUN TO SOFTEN PAINT BEFORE SCRAPING

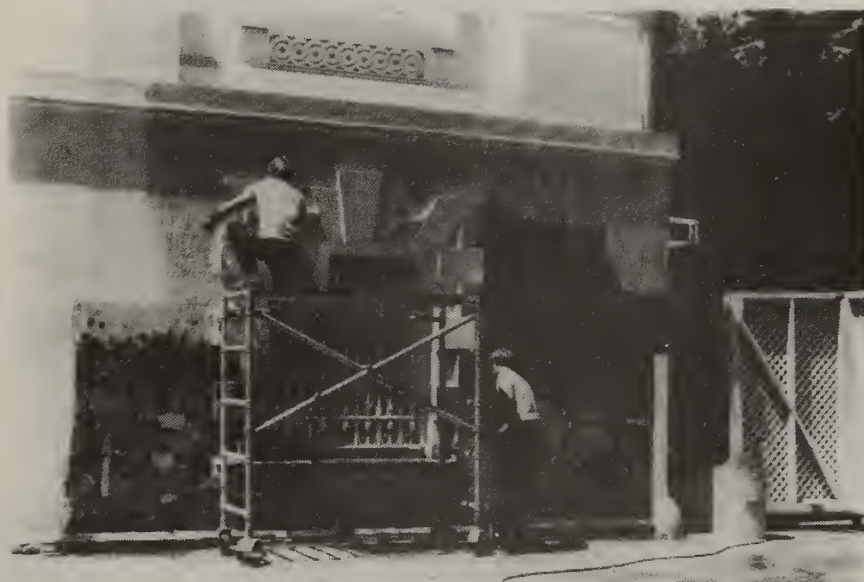
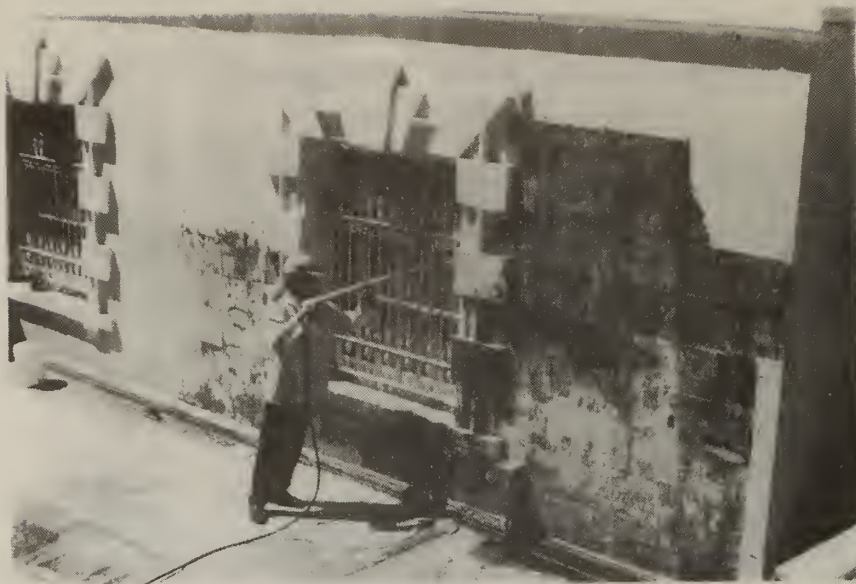
- ° The paint remover was applied by bristle brush to the painted surface and allowed to stand 10 to 15 minutes.
- ° The paint was then scoured with brushes.
- ° Additional paint remover was added and allowed to remain undisturbed for 10 to 30 minutes.
- ° The softened paint was rinsed off with water spray at a low pressure and then with high pressure [1000 to 1700 psi (6.9-11.7MPa)].
- ° The above steps were repeated until all the paint had been removed.

Figures 25 and 26 illustrate the operation of Company 1. They utilized the White House movable scaffold and required 110V electrical and water services.

FIGURE 25. PAINT REMOVAL IN AREA B, APPLICATION OF PAINT REMOVER

FIGURE 26. PAINT REMOVAL IN AREA B, WASHING AWAY SOFTENED PAINT WITH WATER SPRAY

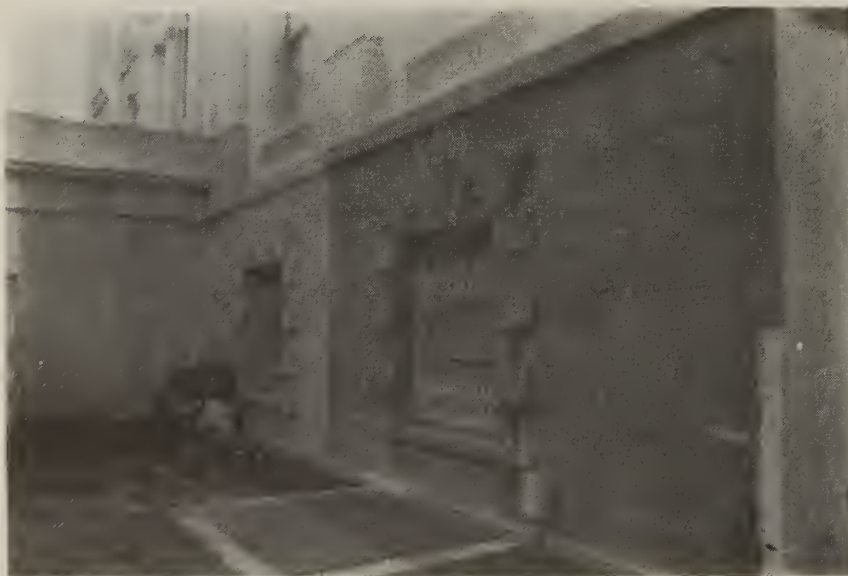
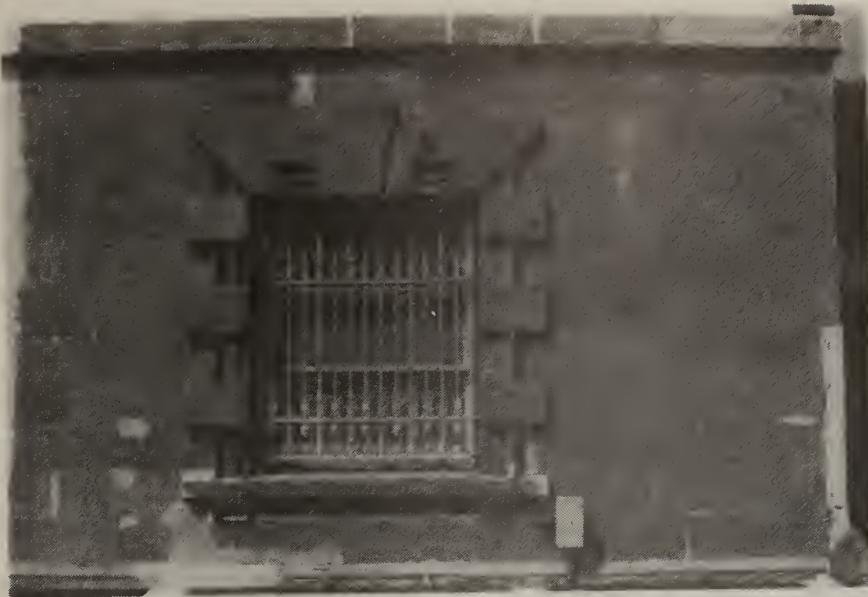
FIGURE 27. AREA A (BEFORE PAINT REMOVAL) AND AREA B (PAINT REMOVED)

FIGURE 28. AREA B, AFTER PAINT REMOVAL

Their compressor had no sound insulation and may need modification for extended usage around a sound sensitive area. Figures 27 and 28 show that the process was effective at removing paint from the sandstone.

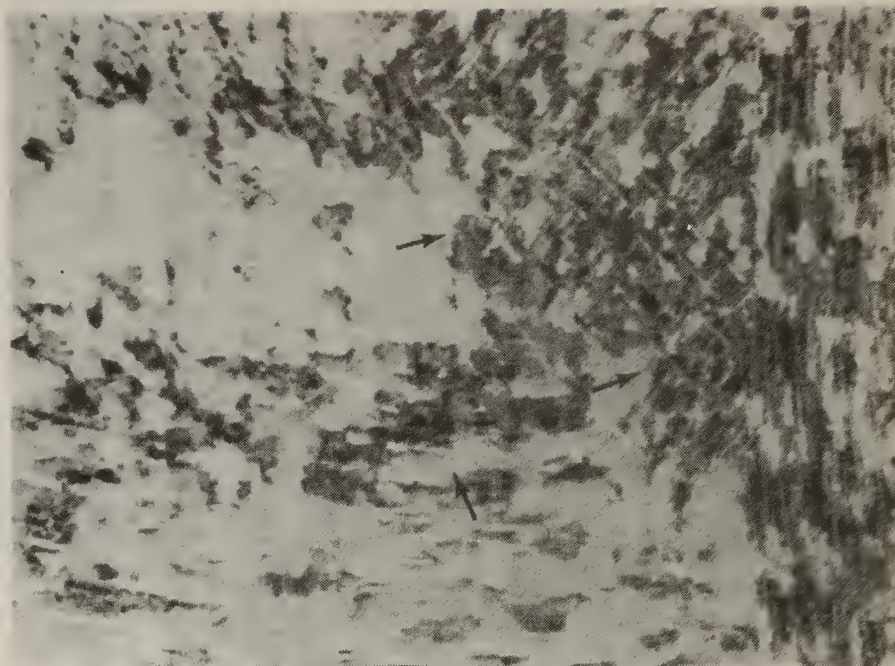
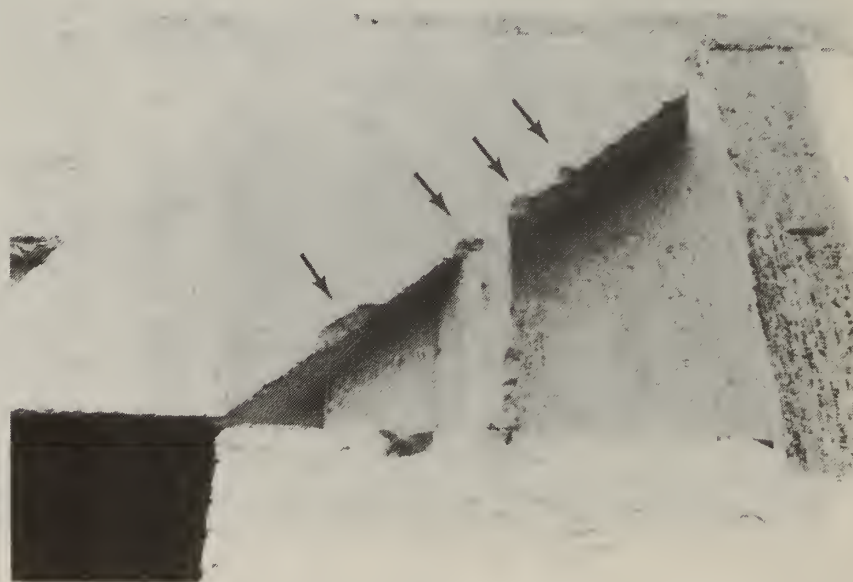
The White House painting crew removed paint from Area D using hand scraping and chipping. Paint chips were caught on drop cloths spread next to the wall. Loose paint was removed with scrapers. Adherent paint was removed by lightly tapping with the flat chisel-head blade of a hammer (figure 30). Surface details of the cleaned stone are shown in figure 31-33. Figure 34 shows Area D with most of the paint removed. It is apparent from figure 34 that most of the paint was removed by this process. But the sandstone can be easily damaged by the process as shown in figures 32 and 33.

FIGURE 32. AREA D, PAINT REMOVED BY CHIPPING, ARROWS INDICATE IMPACT MARKS OF HAMMER BLADE

FIGURE 33. AREA D, ARROWS INDICATE PLACES WHERE STONE WAS CHIPPED BY PAINT REMOVAL

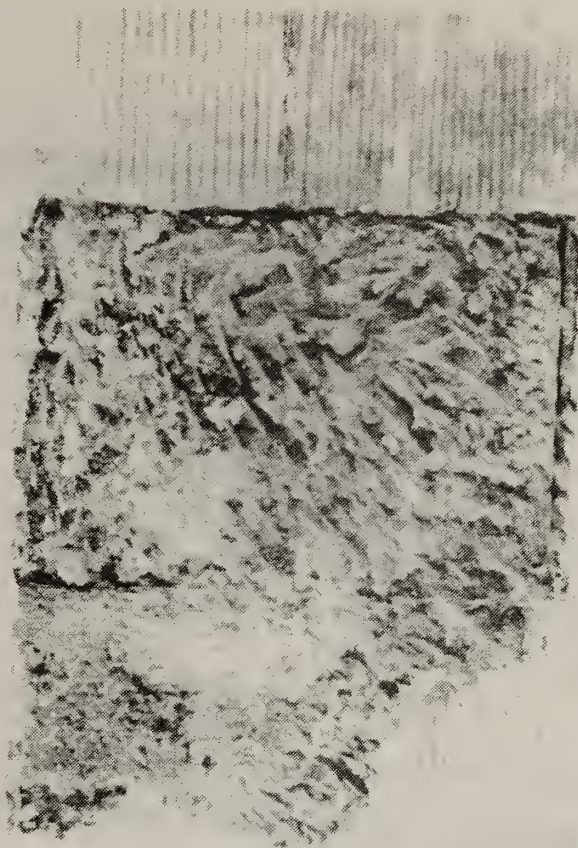
FIGURE 35. AREA A, DECAYED STONE REPAIR, EXPOSED BY PAINT REMOVAL

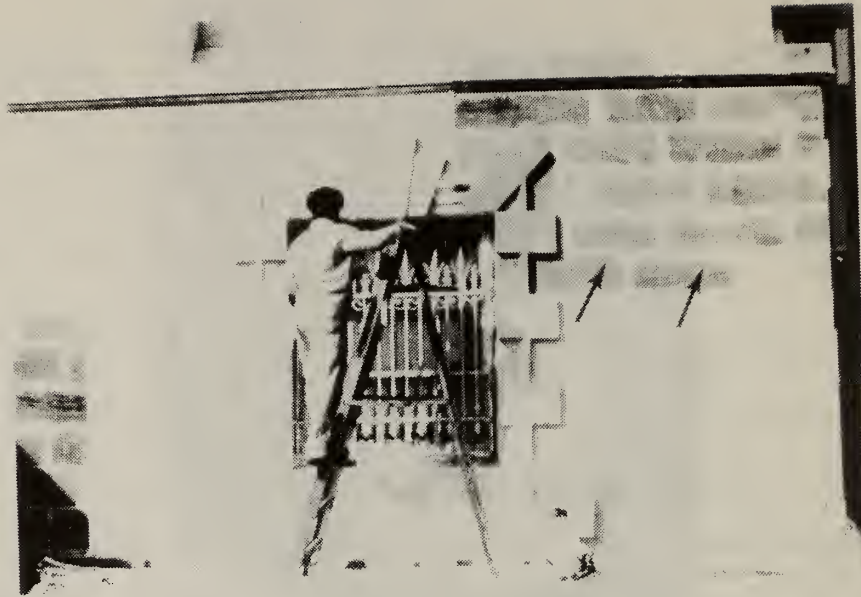
FIGURE 37. REPAINTING OF AREA B, ARROWS INDICATE BROAD AREA OF EXCESS MORTAR AFTER REPOINTING

Hess [23] for discussions on this type of failure). None of the other coating materials applied exhibited any similar surface cracking. As noted earlier, repointing in Area B resulted in some powdery mortar material remaining on the surface which was not removed prior to painting (see figure 37). However, no delamination was observed in the affected mortar joint area. In the May 1979 inspection, Coating 3 appeared to be darker in comparison to the other coatings but the amount of surface cracking, noted during the March inspection on Coating 1, did not appear to increase. Some delamination of Coating 2 was observed in Test Area A and all four coatings exhibited delaminations in Area C. These paint failures were due to the poor adhesion of the old paint layers that had not been removed by cleaning prior to repainting. Figures 47 and 48 illustrate this type of failure which is typical of the paint failures observed in the past on the Residence.

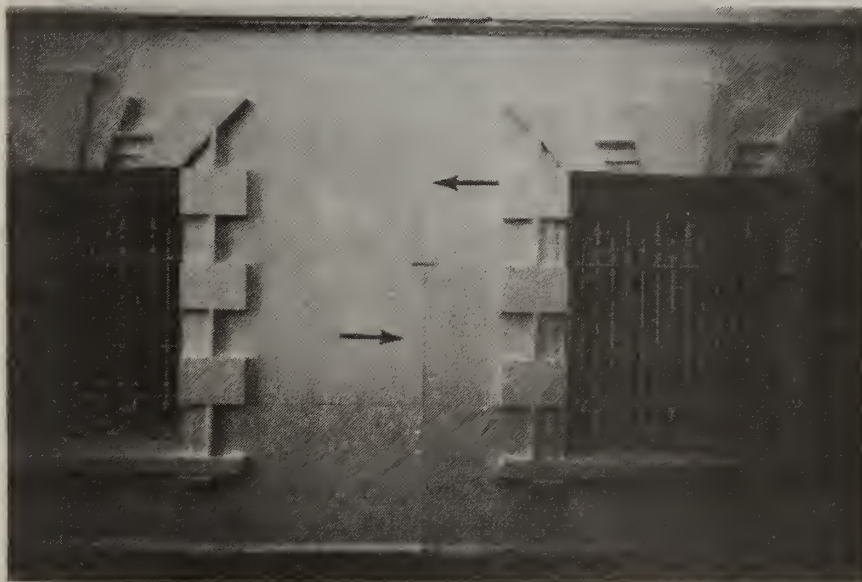
FIGURE 45. AREA D AFTER REPAINTING; ARROWS INDICATE VERTICAL LINE DIVIDING TEST SECTIONS D4 AND D1 (TO LEFT) FROM SECTIONS D2 AND D3 (TO RIGHT)

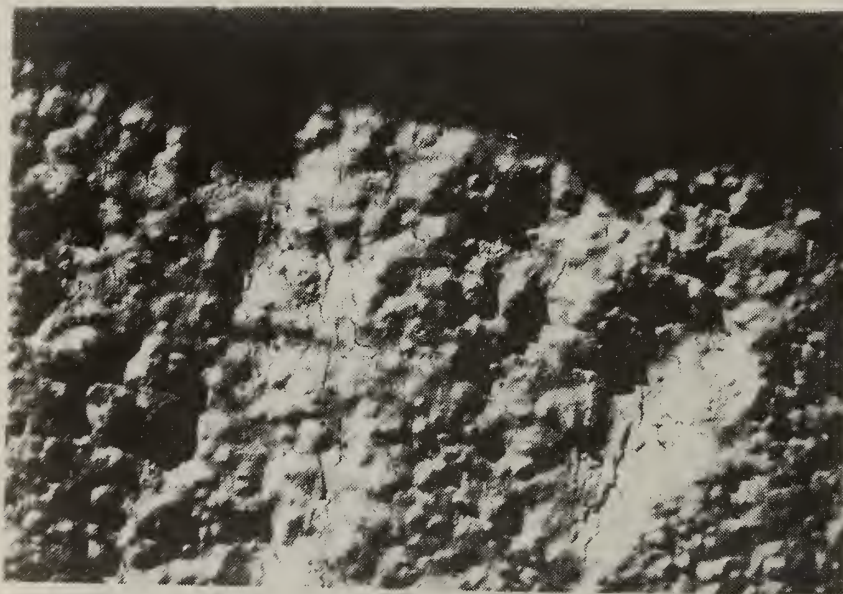
In the March 1979 inspection, surface cracking of the acrylic paint (Coating 1) was observed in all four paint removal areas. The cracks did not appear to penetrate through both layers of paint and appeared to be due to an excessive paint buildup. Figure 46 illustrates the type of surface cracking observed. Painting conditions for both coats of paint were good; temperatures during the application of the second coat on October 26, 1978 ranged from 60 to 82°F (15 to 27°C) and only light precipitation of 0.01 in (0.025 mm) occurred at midnight. Since none of the Coating 1 panels involved in the UV laboratory exposure tests or the exposure test on the roof of the Residence exhibited any cracking, we surmise that an excessive coating thickness of the second coat may have been responsible for the incipient failures (see

FIGURE 46. SURFACE CRACKS IN COATING 1; 1:1 EXPOSURE, MARCH 1979

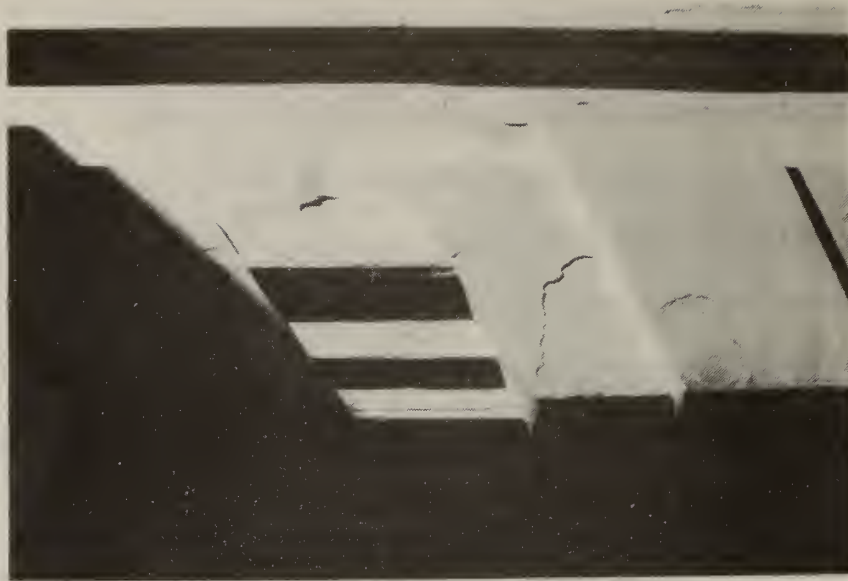
FIGURE 47. PAINT DELAMINATION IN AREA A, MAY 1979
